*OMAP3530/25/15/03 Applications Processor*  
**Silicon Revisions 3.0, 2.1, and 2.0**

# Silicon Errata

Literature Number: SPRZ278B  
February 2008–Revised August 2008

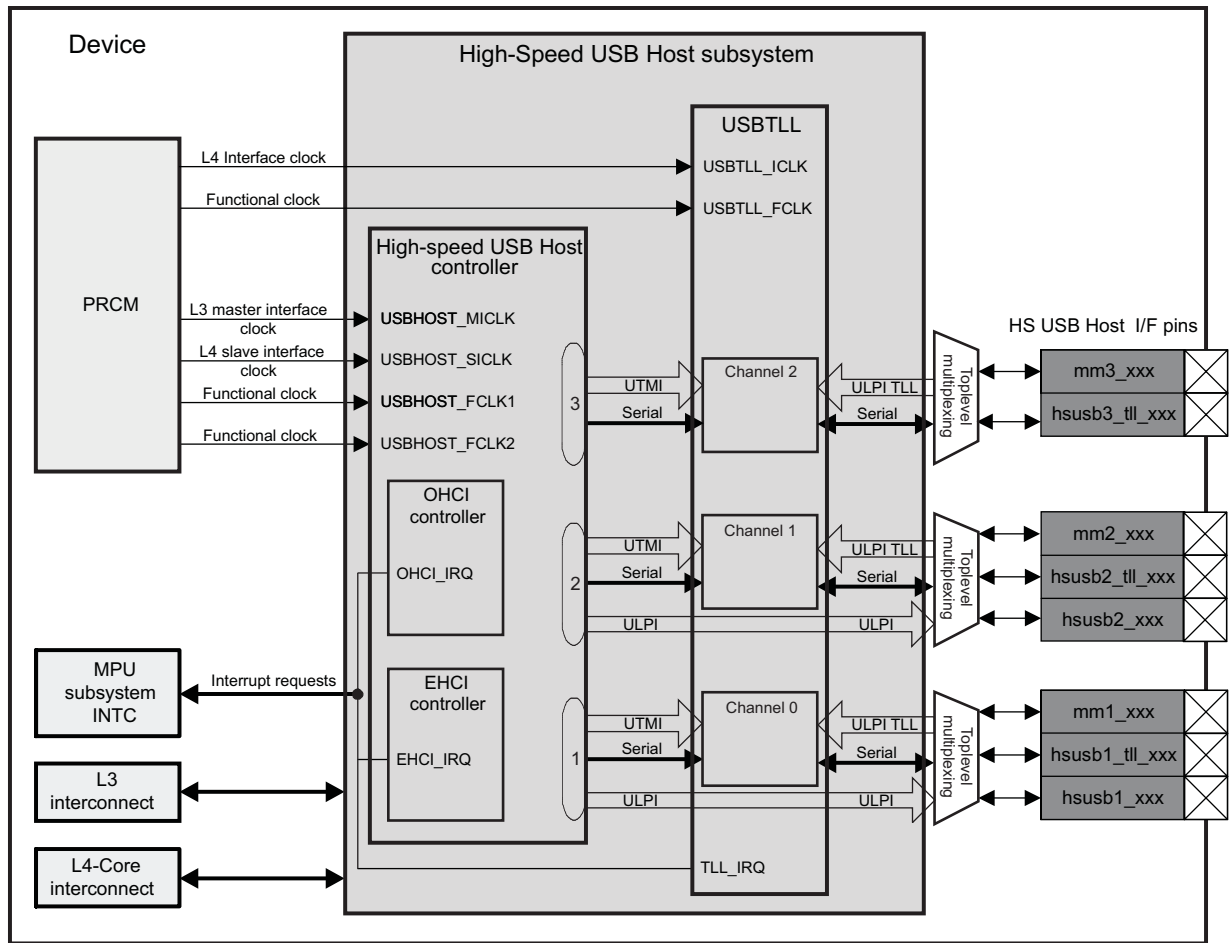
Figure 4. High-Speed USB Host Subsystem Highlight

- On silicon revision 3.0 and earlier, if one port is configured in the ULPI mode, then all other ports must use the same configuration. Therefore, the ports must be configured high-speed mode or full-speed/low-speed mode.
- USB Port 3 cannot operate in ULPI mode; it can only operate in serial or ULPI TLL mode. Furthermore, USB Port 3 is not available in the CUS package.

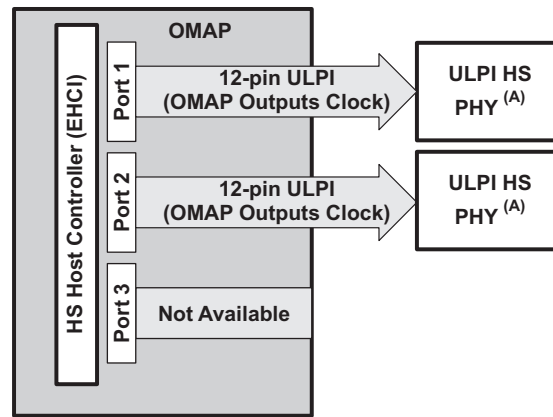
Figure 5. Connecting to High-Speed PHYs Using USB Ports

As shown in Figure 5, USB Port 1 and Port 2 can be used to connect to external high-speed PHYs which include a ULPI port. However, in this case, the external USB PHY must be able to accept a source clock generated by the OMAP high-speed USB controller. Also, in this usage model the USB ports cannot support full-speed and low-speed operation. Therefore, using this approach, USB Port 1 and Port 2 cannot provide a fully compliant USB 2.0 Type-A receptacle; a high-speed USB hub would be required in this case; please see Figure 6.

A. USB port 3 does not support ULPI mode.  
Also, USB port 3 not available on CUS package.

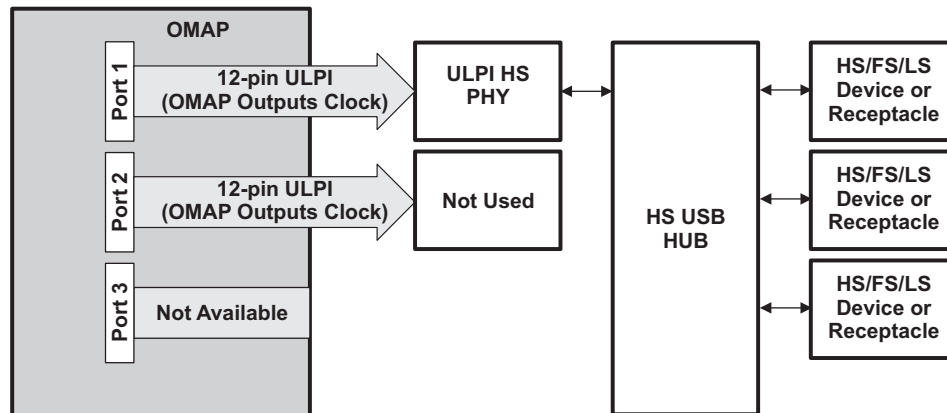
Figure 6. Connecting to a High-Speed USB Hub

A. USB port 3 does not support ULPI mode. Also, USB port 3 not available on CUS package.

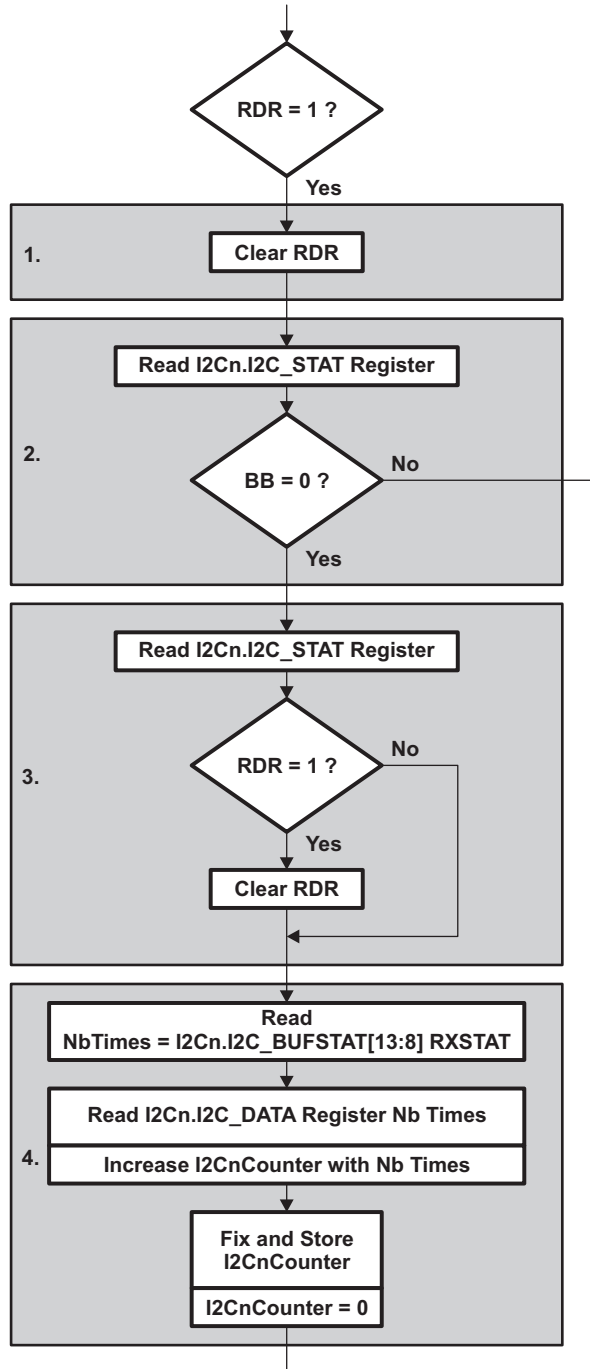
**Figure 7. I2C Flowchart**

**Details** Under certain rare conditions, the I2C\_STAT[13].RDR bit may be set as well as the corresponding interrupt fire, even when there is no data in the receive FIFO, or the I2C data transfer is still ongoing. These spurious RDR events must be ignored by the software.

**Workaround(s)** Software must filter out unexpected RDR pulses, using the flowchart illustrated in [Figure 7](#) when receiving an I2C RDR interrupt.

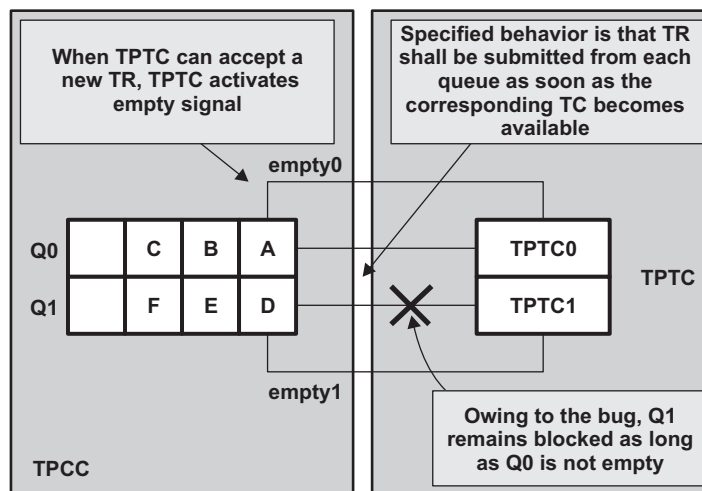
**Figure 8. TR Submission Scheme**

**Details** The EDMA channel controller (TPCC) has 2 event queues: Q0 and Q1. Each queue can be mapped to one of the two Transfer Controllers (TPTC): TPTC0 or TPTC1. As explained in the *OMAP35x Technical Reference Manual* (literature number [SPRUF98](#)), the events in each event queue will be extracted as soon as the corresponding TPTC is available for a new Transfer Request (TR) to be programmed into the TPTC. However, due to an issue in the IVA2.2 subsystem, the requests queued in Q1 cannot be submitted to their TPTC as long as Q0 is not empty.

**Workaround(s)** Infrequent short transfers (e.g., latency critical synchronized transfers to/from peripheral) must be placed in Q0, and longer transfers (e.g., block copy) in Q1. For example, when a latency critical transfer is placed in EDMA and a longer transfer in QDMA, the following programming model will minimize the impact of this limitation:

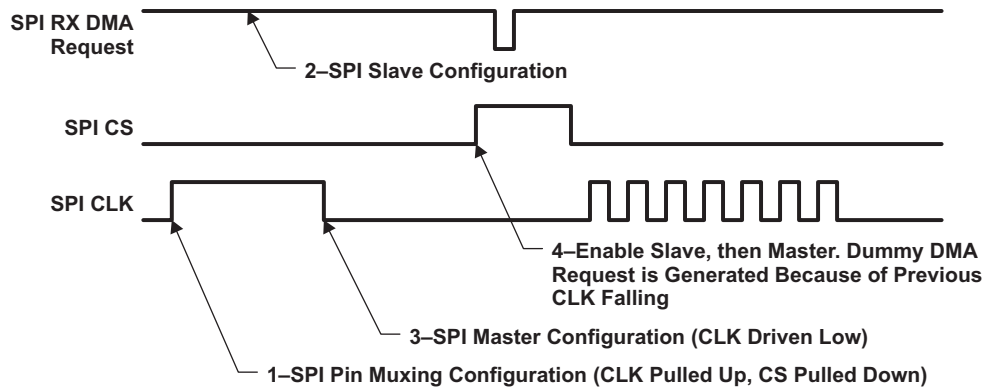
**Figure 9. SPI Dummy DMA RX Generation**

**Details** A dummy DMA RX request is generated as soon as the SPI is configured in *slave* mode and a SPI clock edge is detected. The dummy DMA RX request is generated during module configuration, when the module is not performing an SPI transfer. The dummy DMA RX request occurs as soon as the SPI interface signal sensitivity is changed compared to the default value.

The dummy DMA RX request is generated because the mechanism to avoid dummy data capture on a CS glitch is done regardless of channel activation.

**Workaround(s)** Avoid conditions where the SPI is in *slave* mode and the SPI clock toggles (see examples below).

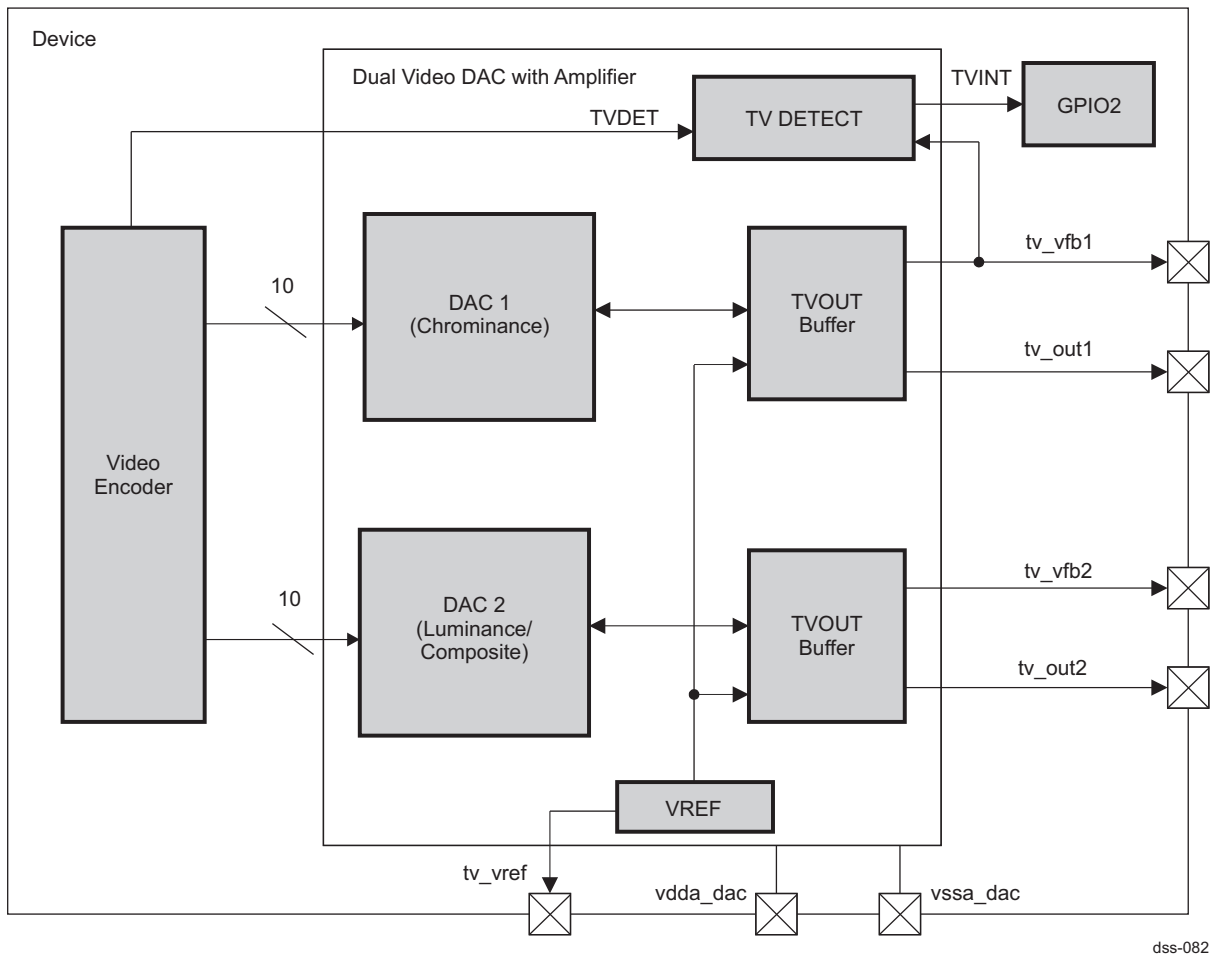
**Figure 13. DAC Implementation**

Furthermore, for proper TV detection in composite video mode (CVBS), DAC1 should be used for luminance and DAC2 for chrominance. Therefore, as a direct consequence of implementation, the TV detect feature is not available for composite video mode.
