# **TMS320C6455/54**

## **Digital Signal Processor**

### **Silicon Revisions 2.0, 1.1**

## **Silicon Errata**

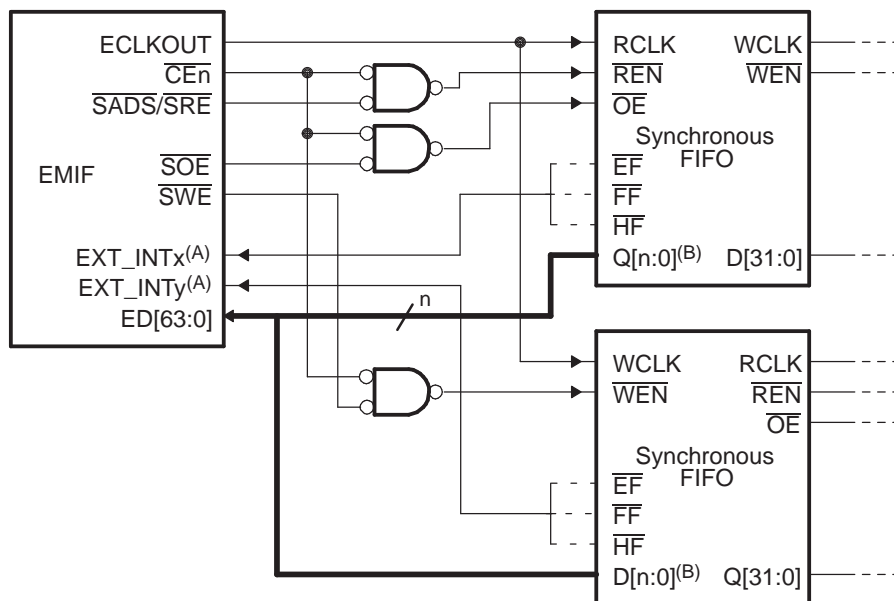
**Figure 2. Read and Write Synchronous FIFO Interface With Glue Block Diagram**

The state of the EMIFA control pins is not defined while the chip enable pins ( $\overline{CE}[5:2]$ ) are high. Furthermore, some control pins may become active while the chip enable pins are driven high. To avoid erroneously activating devices connected to EMIFA, the chip enable pins should be used to select/deselect these devices. If a device being used does not have a chip enable input, then the control pins going to that device should be qualified with a chip enable pin. An example of this is shown in Figure 2.

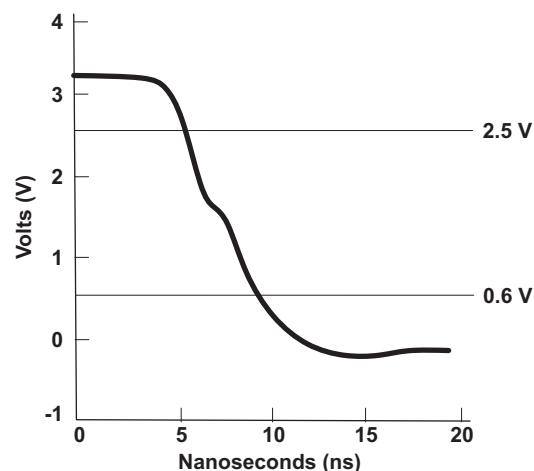
**Figure 3. Bad TCK Transition**

This phenomenon is observed when an erroneous clock edge is generated from the TCK signal inside the C64x+ DSP. This can be caused by several factors, acting independently or cumulatively:

A TCK edge that can cause this problem might look similar to the one shown in [Figure 3](#). A TCK edge that does not cause the problem will look similar to the one shown in [Figure 4](#). The key difference between the two figures is that [Figure 4](#) has a clean and sharp transition whereas [Figure 3](#) has a "knee" in the transition zone. Problematic TCK signals may not have a knee that is as pronounced as the one in [Figure 3](#). Due to the TCK signal amplification inside the chip, any perturbation of the signal can create erroneous clock edges.

When examining a TCK signal for this issue, either in board simulation or on an actual board, it is very important to probe the TCK line as close to the DSP input pin as possible. In simulation, it should not be difficult to probe right at the DSP input. For most physical boards, this means using the via for the TCK pad on the back side of the board. Similarly, ground for the probe should come from one of the nearby ground pad vias to minimize EMI noise picked up by the probe.

As the problem may be caused by one or more of the above factors, one or more of the steps outlined below may be necessary to fix it:

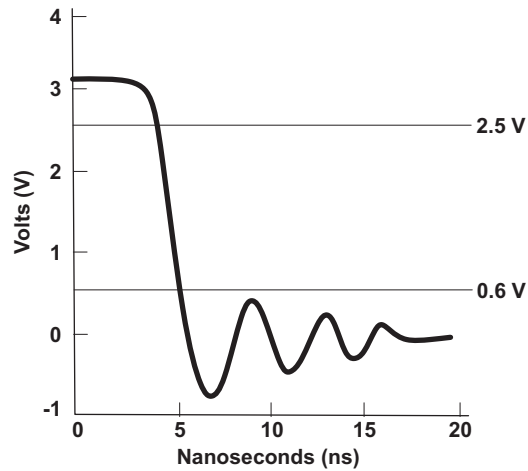
**Figure 4. Good TCK Transition**

As a result of the faster edge transition, there is increased ringing in [Figure 4](#). As long as the ringing does not cross logic input thresholds (0.6 V for falling edges, and 2.5 V for rising edges), this ringing is acceptable.

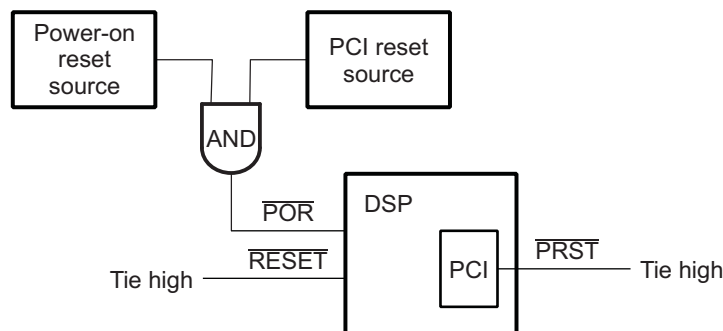
**Figure 6. Example With  $\overline{RESET}$  and  $\overline{PRST}$  Pins Tied High**

The PCI module can lock up or go into a bad state if its internal and external resets are asserted independently, meaning one is asserted and the other is not. Power-on and warm reset are controlled differently from system to system and, therefore, the effect of this issue is system specific.

**Workaround(s):** Systems should be designed such that a power-on or warm reset always generates the PCI reset and vice versa. Example circuits that ensure both the chip resets and the PCI reset are asserted together are shown in Figure 6, Figure 7, and Figure 8. Note that asserting power-on reset also asserts PCI reset internally. Also, since a PCI reset will cause a chip reset, the configuration pins of the device will also be latched on a PCI reset. Therefore, these pins must be at valid levels to ensure the device is taken out of reset in the desired mode.

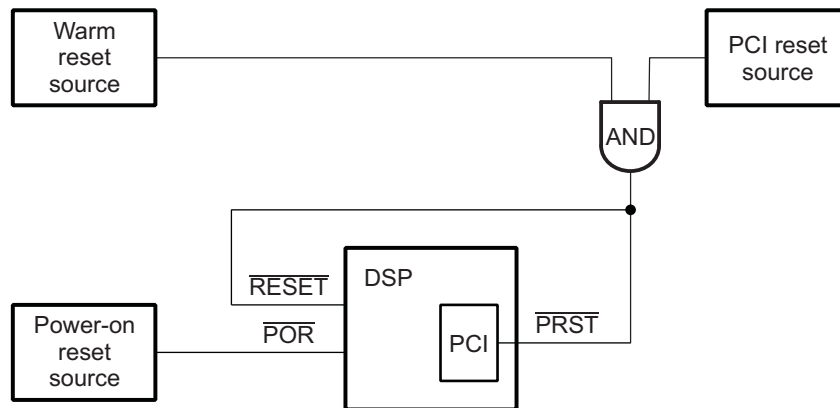
Figure 8. Example With Independent Power-On Reset, Warm Reset, and PCI Reset Sources

Note that in the above circuits a power-on or warm reset will reset the DSP and its PCI only; other devices on the PCI bus will not be reset. To avoid interrupting an ongoing PCI transaction to/from the DSP, the DSP PCI should be *disconnected* from the PCI system. The sequence below ensures that the DSP PCI is *disconnected* from the PCI system. This sequence can be executed by the DSP itself or by an external host. Note that resetting the DSP PCI in the middle of a master or slave transaction can cause a PCI bus fault at the system level.

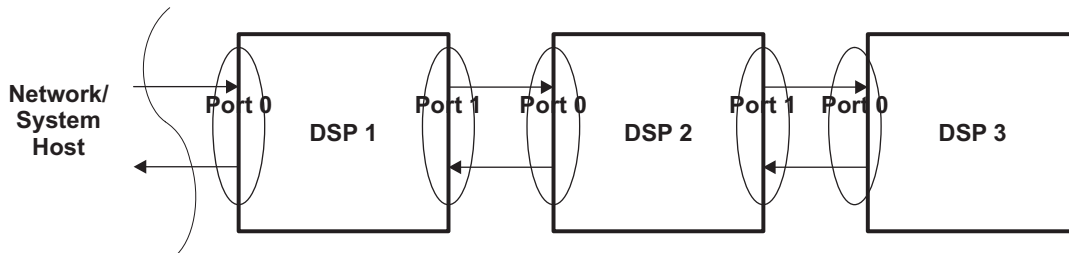
**Figure 9. Daisy-Chain Example**

The current SRIO design fails to correctly copy response packets with a payload greater than 16 bytes from the inbound to the outbound buffer. The first 16 bytes are correctly copied, but the remainder of the payload is discarded. This issue affects only NREAD response packets since their payloads can be up to 256 bytes. Packet types with small responses, such as NWRITE\_R, maintenance, message, and DOORBELL packets are not affected by this issue.

**Workaround 2:** Two options exist if NREAD response packets cannot be avoided; for example, when reading core dump information from an unresponsive processor which is unable to initiate traffic by itself. The first option is to use software to segment read requests into 16-byte NREADs. Note that this option will work functionally, but may take too much time.

The second option is illustrated in [Figure 9](#).

In this example, assume that DSP3 is down and the system host wants to do a large NREAD of DSP3 to examine the core dump. The issue discussed above prohibits the NREAD from completing correctly because, as the response packets from DSP3 are sent back, they are corrupted by DSP2 and DSP1 packet forwarding. Instead, the system host needs to request that the adjacent DSP (DSP2) generates the NREAD request to DSP3. The NREAD responses are sent to DSP2 and temporarily stored in memory. Then, DSP2 can generate NWRITE/NWRITE\_R/SWRITE packets to the system host with the needed payload. These packets are correctly forwarded by DSP1 to the system host since they are request packets and not responses.

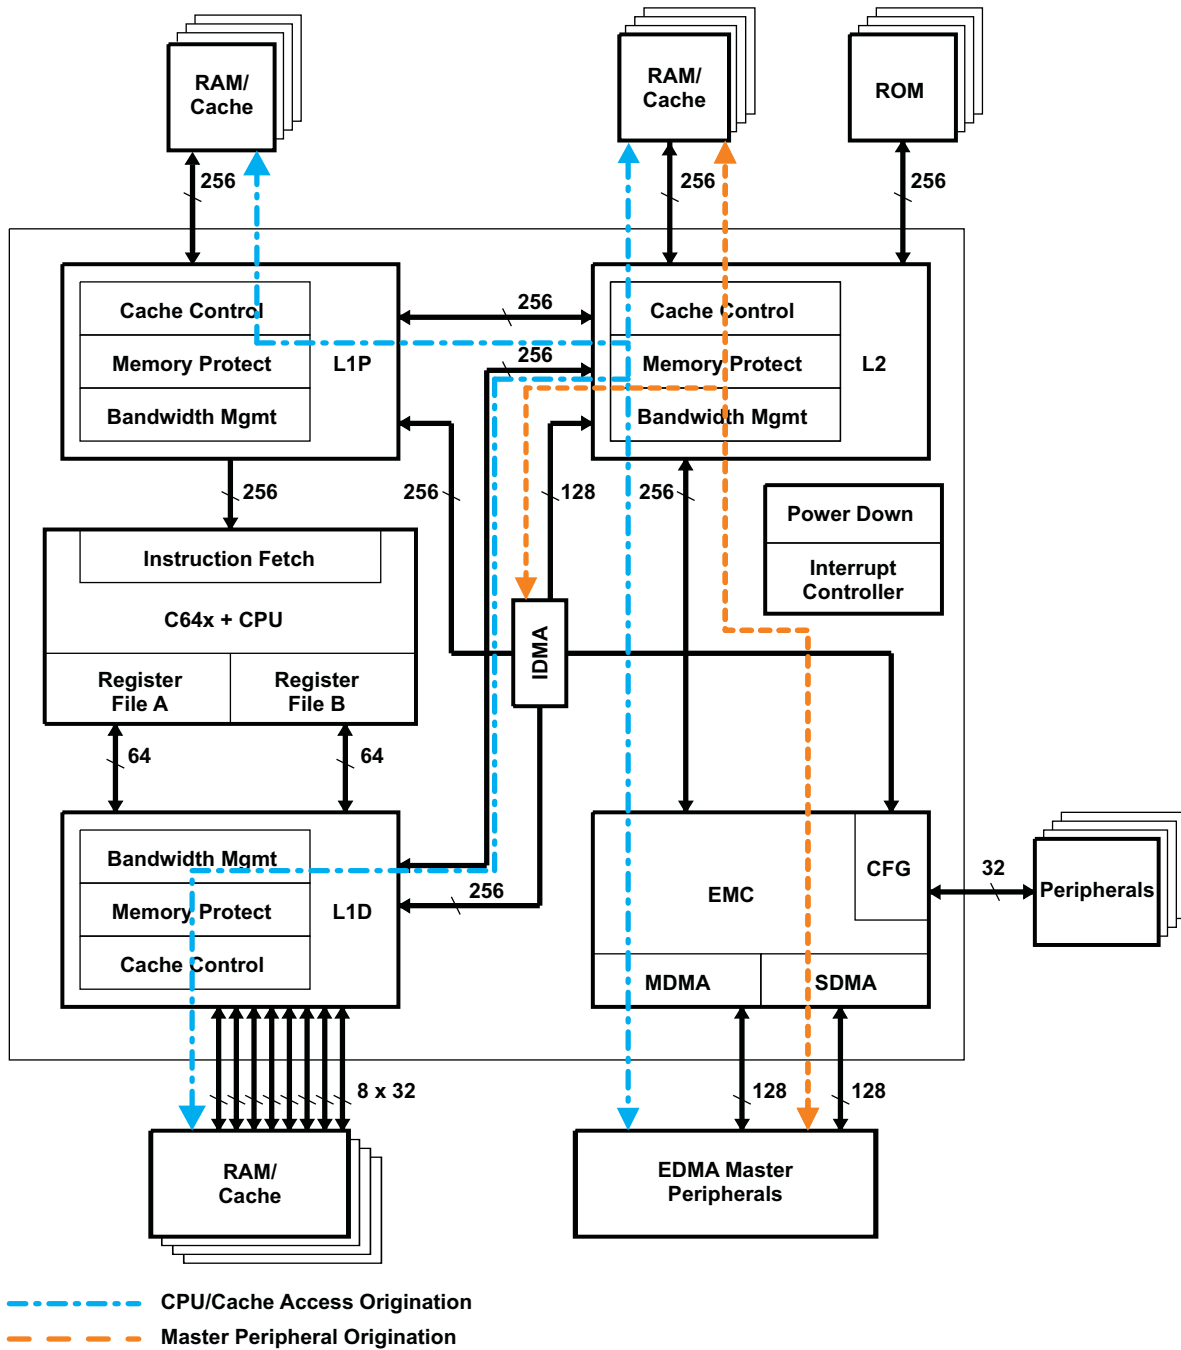
Figure 10. IDMA, SDMA, and MDMA Paths

Ideally, the MDMA (the blue lines in [Figure 10](#)) and SDMA/IDMA paths (the orange lines in [Figure 10](#)) operate independently with minimal interference. Normally, MDMA accesses may stall for extended periods of time (clock cycles) due to expected system level delays (e.g., bandwidth limitations, DDR2 memory refreshes). However, when using L2 as RAM, SDMA and/or IDMA accesses to L2/L1 may experience unexpected stalling in addition to the normal stalls seen by the MDMA interface. For latency-sensitive traffic, the SDMA stall can result in missing real-time deadlines. In a more severe case, the SDMA stall can produce a deadlock condition in the device.

[Figure 10](#) is a simplified view for illustrative purposes only. The IDMA/SDMA path (orange lines) can also go to L1D/L1P memories and IDMA can go to the DSP CFG peripherals. MDMA transactions (blue lines) can also originate from L1P or L1D through the L2 controller or directly from the DSP.
