*OMAP3530/25/15/03 Applications Processor*  
**Silicon Revisions 3.0, 2.1, and 2.0**

# Silicon Errata

Literature Number: SPRZ278B  
February 2008–Revised August 2008

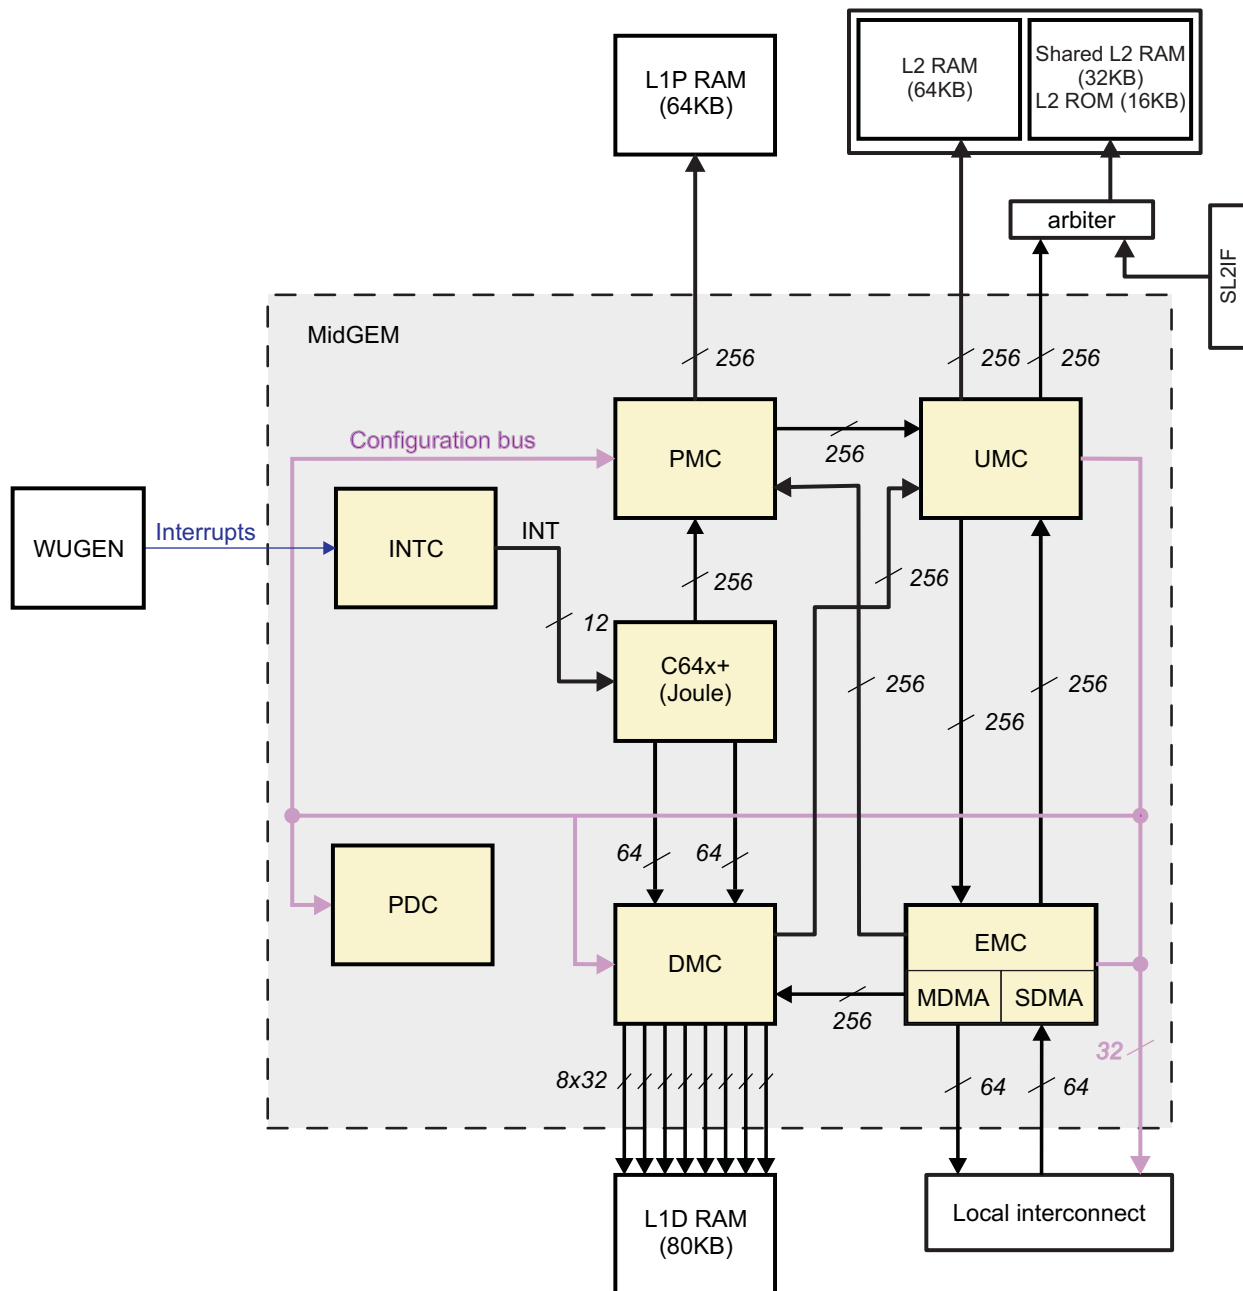
**Figure 12. C64x+ Megamodule Block Diagram**

Ideally the MDMA and SDMA/IDMA paths operate independently with minimal interference. Normally MDMA accesses may stall for extended periods of time (clock cycles) due to expected system level delays (e.g. due to bandwidth limitations and/or DDR memory refreshes). However, due to the exception, there are cases where SDMA and/or IDMA accesses to L2/L1 experience an additional/unexpected stall during the normal stalls seen by the MDMA interface. For latency sensitive traffic, the SDMA stall can result in missing real time deadlines.

**NOTE:** SDMA/IDMA accesses to L1P/D will not see any unexpected stall if there are no SDMA/IDMA accesses to L2 (both cache/SRAM and shared SRAM). This is because unexpected SDMA/IDMA stalls to L1 happen only when they are pipelined behind L2 accesses which experience stalls due to the exception.
