# **TMS320C6455/54**

## **Digital Signal Processor**

### **Silicon Revisions 2.0, 1.1**

## **Silicon Errata**

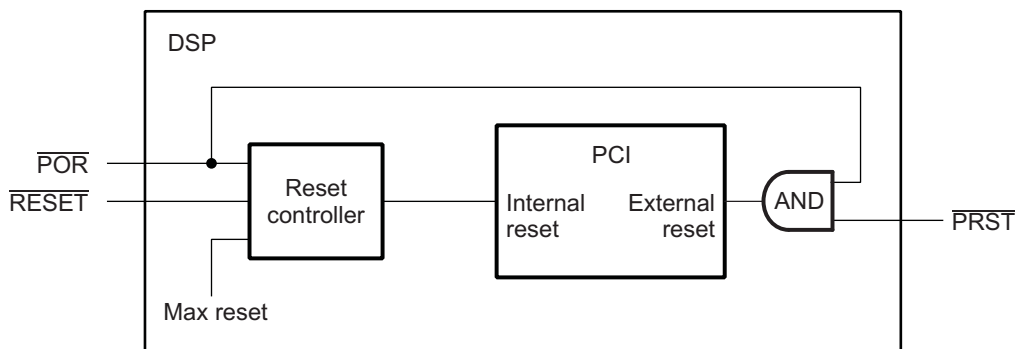
**Figure 5. Internal Reset Asserted By Reset Controller**

**Details:** The PCI module in the C6455/54 device has an internal and an external reset source. The internal reset is asserted by the reset controller during power-on, warm, and max reset, see Figure 5. The internal reset is also asserted when the device state control registers are used to disable the PCI module. The external reset is asserted through the PCI reset pin,  $\overline{PRST}$ .

The PCI module can lock up or go into a bad state if its internal and external resets are asserted independently, meaning one is asserted and the other is not. Power-on and warm reset are controlled differently from system to system and, therefore, the effect of this issue is system specific.

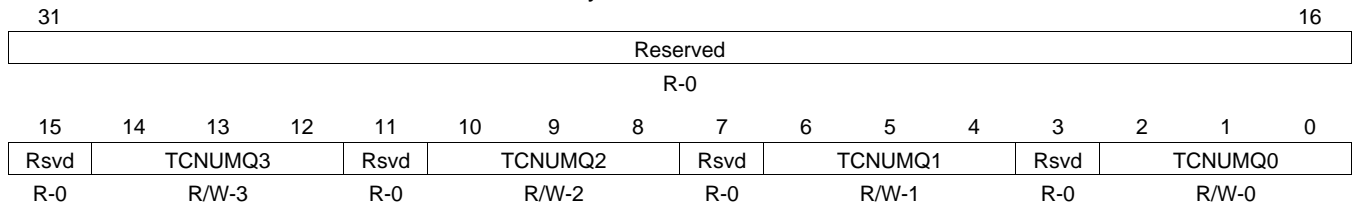
**Figure 11. QUETCMAP Register (02A0 0280h)**

For example, abiding by the default settings, McBSP events need to be submitted on Q1 since TC1 is the only TC with connectivity to this peripheral. McBSP transfers might be at risk if there are events pending on Q0. In order to reduce this risk, the default mapping of Q0 can be changed such that it maps to TC1. In this manner, an event on Q0 results in a TR submission to TC1 thus minimizing the risk of a real-time miss due to this issue.

2. By default, each queue maps directly to a corresponding transfer controller (TC); i.e., Q0 maps to TC0, Q1 maps to TC1, etc. If there is a real-time requirement for servicing a peripheral which cannot be accessed via TC0, then Q0 can be mapped to the TC through which the peripheral can be accessed. Queue to TC mapping can be changed via software through the QUETCMAP register (see [Figure 11](#) and [Table 10](#)) as long as only one queue maps to one TC.

Opting for this workaround has other implications on the system. For example, if Q0 is mapped to TC1 then another queue must be mapped to TC0. If Q1 is mapped to TC0, the VCP2 and TCP2 events must be submitted on Q1. Whether this is acceptable would need to be determined by the user.
